MASSACHUSETTS COASTAL BASIN
GLOUCESTER, MASSACHUSETTS

WEST POND OUTLET
MA 00186

**PHASE I INSPECTION REPORT
NATIONAL DAM INSPECTION PROGRAM**

DECEMBER 1979

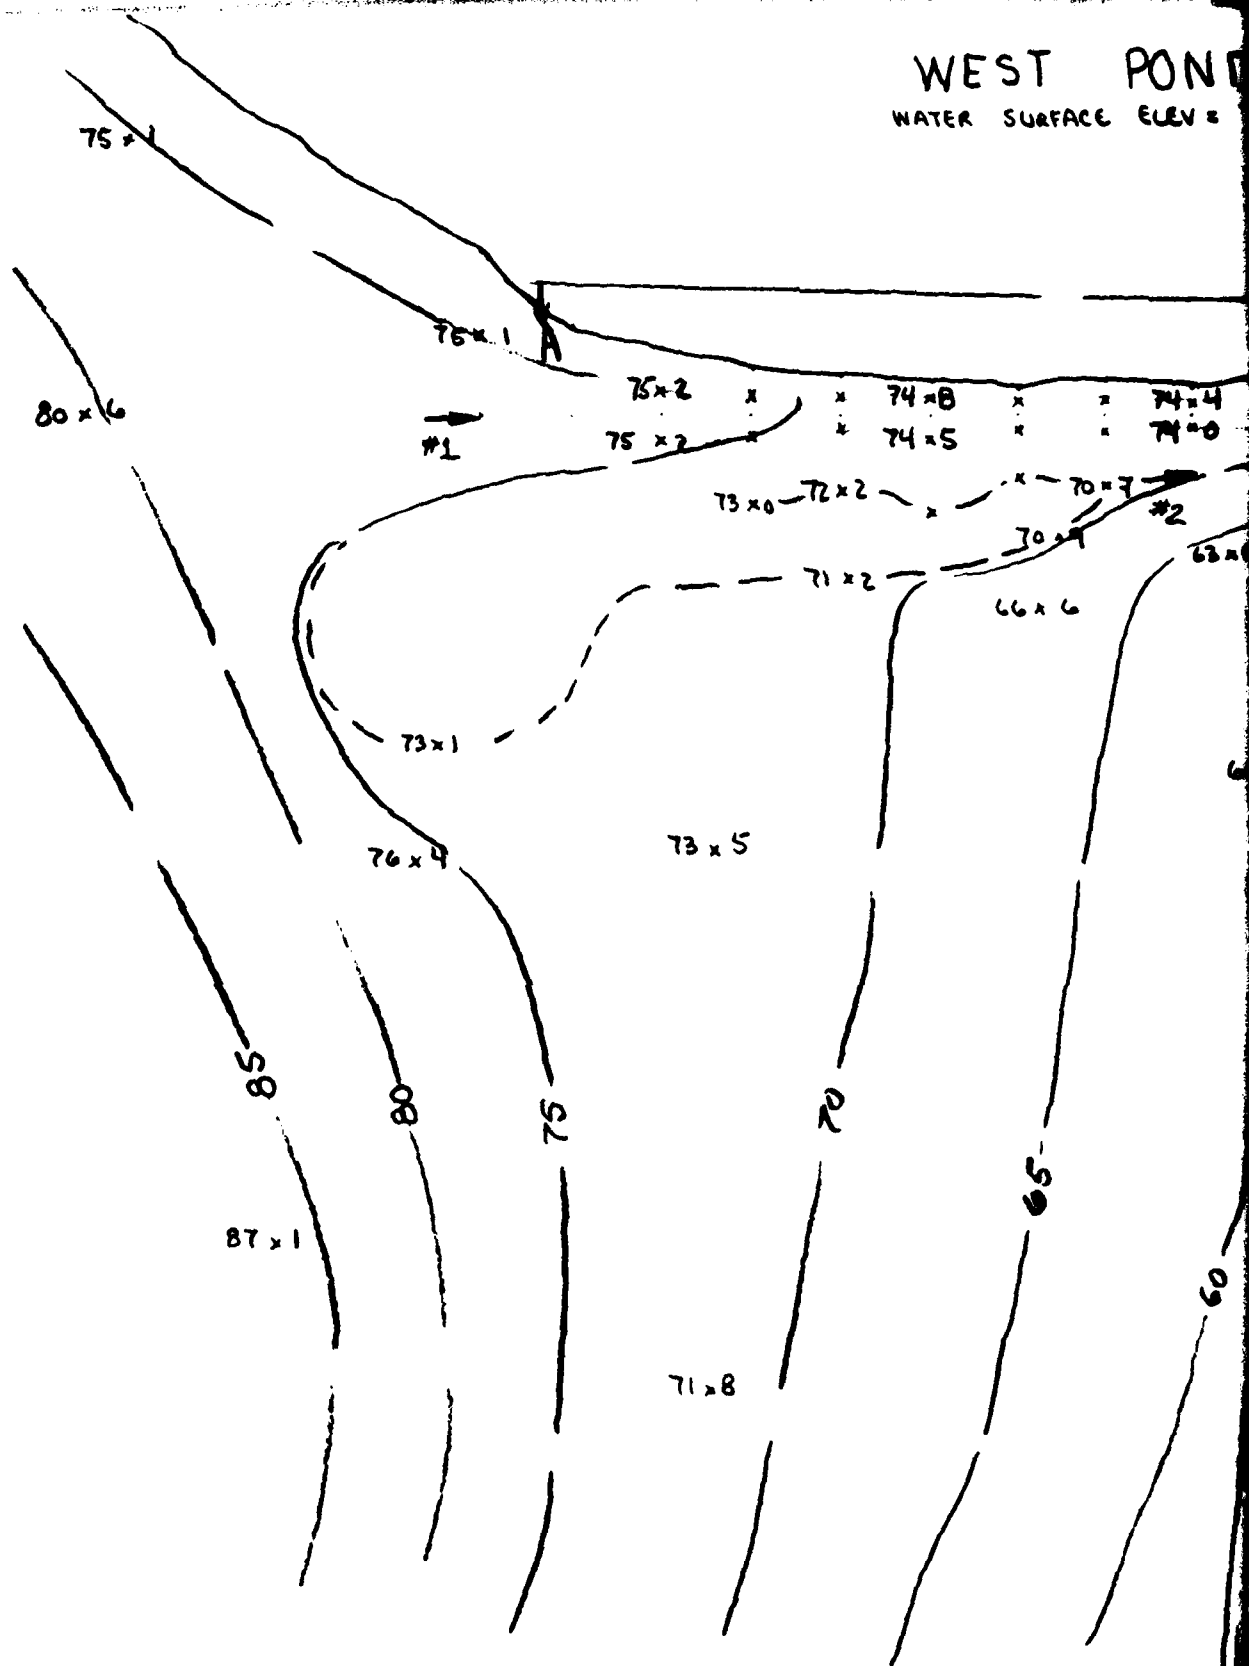
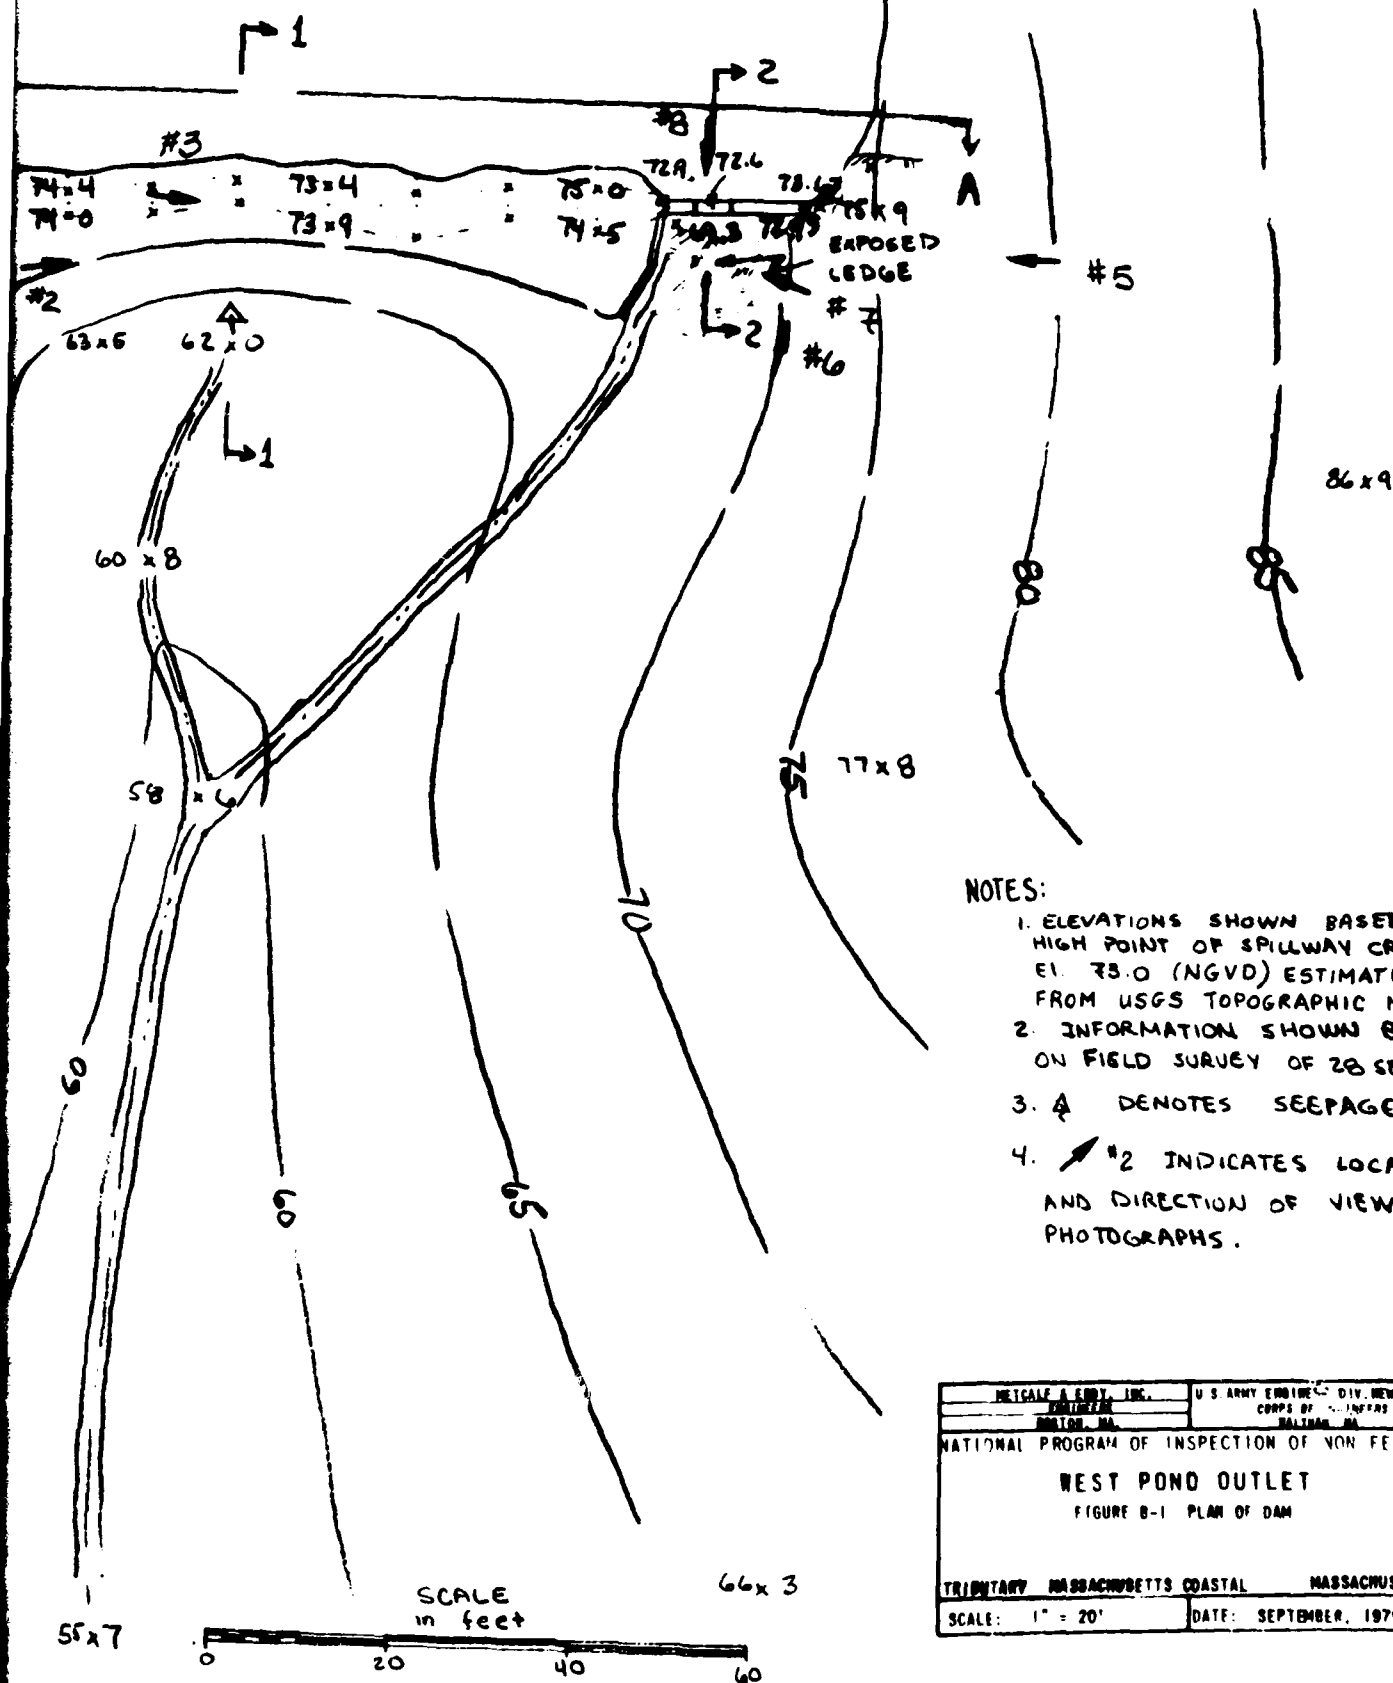
METCALF & EDDY, INC. ENGINEERS BOSTON, MA.		U.S. ARMY ENGINEERING DIV. NEW ENGLAND CORPS OF ENGINEERS BOSTON, MA.	
NATIONAL PROGRAM OF INSPECTION OF NON FED DAMS			
WEST POND OUTLET			
FIGURE B-1 PLAN OF DAM			
TRIBUTARY		MASSACHUSETTS	COASTAL
SCALE: 1" = 20'		DATE: SEPTEMBER, 1979

#2 INDICATES LOCATION AND DIRECTION OF VIEW FOR PHOTOGRAPHS.

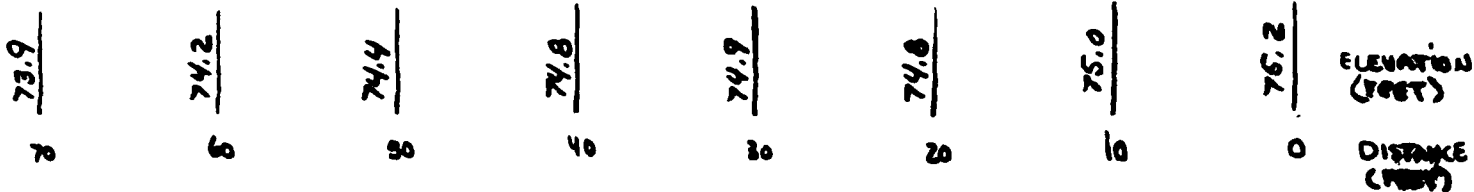
FILE A-A
 AM CREST
 1 in. = 10 FT.

TREES AND BRUSH
 ON SLOPE
 AREAS OF OPEN,
 JOINTED FIELDSTONE
 ALSO APPARENT
 ON SLOPE
